Role of discontinuities in the determination of slope stability at Pattikad along NH-47, Kerala.

Abstract - slope failure is one of the major concerns along highways all around the world. Mannuthi- Kuthiran road segment is one such region which is highly vulnerable and suffers from recurrent rock slide and fall mostly in the rainy season. The steep and highly jointed rock cut cliffs along the road makes the zone prone to slope failure due to the infiltration of water during rainy season. Attempts have been made in this study to understand the stability of the cut cliff. The influence of joints on the stability of slopes is determined using Markland test. The study shows that some sections of the cliff face is highly unstable taking into consideration the environmental condition and heavy traffic. Proper case is to be taken to avoid potential hazard in the area.

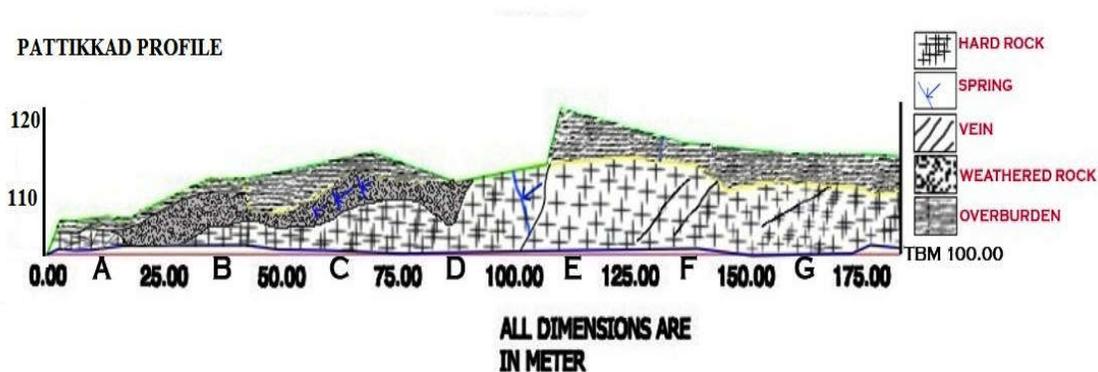
Fig.2: Longitudinal Profile of the Road cut cliff A, B, C, D, E, F and G are sectors

Pattikkad profile is located 15 Km away from Thrissur along the Palakkad road at longitude 76°20' 1.39" and latitude 10° 33' 25.41". The road cut in this locality is very steep. The natural slope of the hillock is 30° towards north. The height of the cut cliff ranges from 3 to 8m. The total length of the profile is 225m (Fig. 2).

Seasonal water seepage is also observed in this area. The road is at an elevation of 120m above MSL. The maximum height of the hillock is 125m. The entire profile is divided into seven sectors: A, B, C, D, E, F and G. Though hill slopes is characterized by mixed vegetations. Road cut cliff is sparsely vegetated. The slope angle of each section, Lithology, unconfined compressive strength, joint types, friction angle, Bulk density, Dip of joint intersection, Types of probable failure, Factor of Safety at dry and wet condition is found out and presented in Table.1

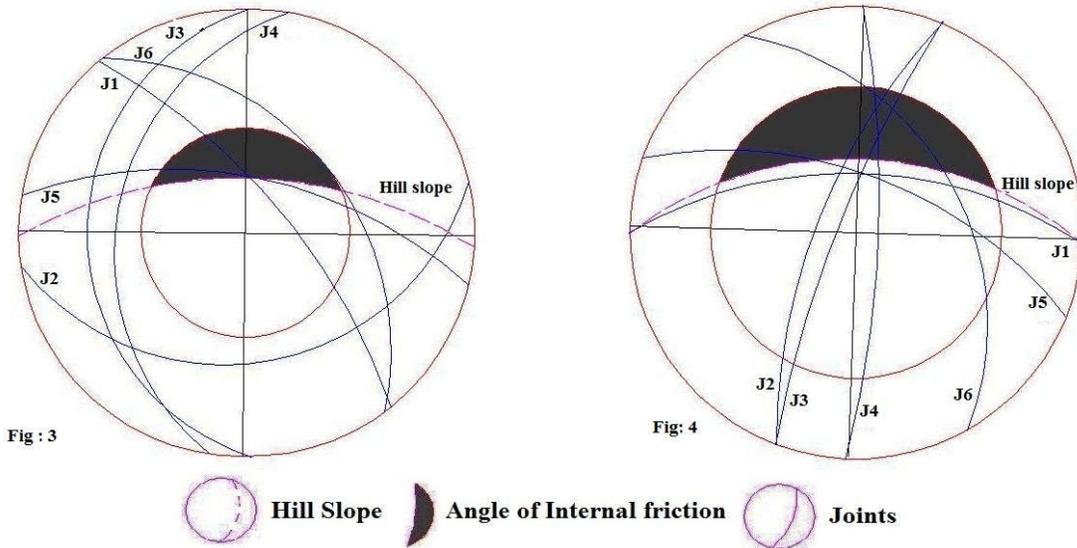
The length of the sector (Fig.3) is 25 m and the height of the cult cliff is ranges from 3.5m-4m. The slope of cut cliff is 60° towards N. There are four major joints (A type) in the sector. Probability for the occurrences of the wedge and plane failure is identified from the β diagram (Fig. 3). Factor safety of the slope is 0.89, when the rocks are wet. Intersection of J1 and J5 falls within the crescent shaped area. The plunge of the intersection is 60 N 30. Chances of plane failure also exist in the sector along the potential slide surface J5. Factor of safety of the cut slope is 1.453 at dry condition and it becomes unstable during wet condition (FOS 0.89)

Length of the sector is 25 m and the height of the cut cliff is 5m. The cliff is sloping 52° towards north. The major rock type is charnockite and is highly weathered. There are 10 joints including 4 parallel joints in this sector. During rain storms water seeps through the discontinuities and in the presence of water along these joints, factor of safety may be further reduced to 0.45. Occurrences of the wedge failure are probable in this sector. Slumping of debris is seen in the sector B, which consists of boulders weathered rock fragments and lateritic soil (Fig.4). Factor of safety is less than one even when the rock is dry. The intersection of J2 and J6 falls within the crescent shaped area. The plunge of the intersection is 10°N 27 and is the potential slide surface along which a wedge failure can occur. The rock is sitting safely because of the presence of joints with irregular surface.

Fig.3 and 4: β Diagram for Sectors A and B respectively. Broken arcs are the traces of Slopes, the Inner Circle are the Angle of Internal Friction for the materials; Crescent shaped shaded areas represent the Limit for Wedge failure caused by intersection of joint planed.

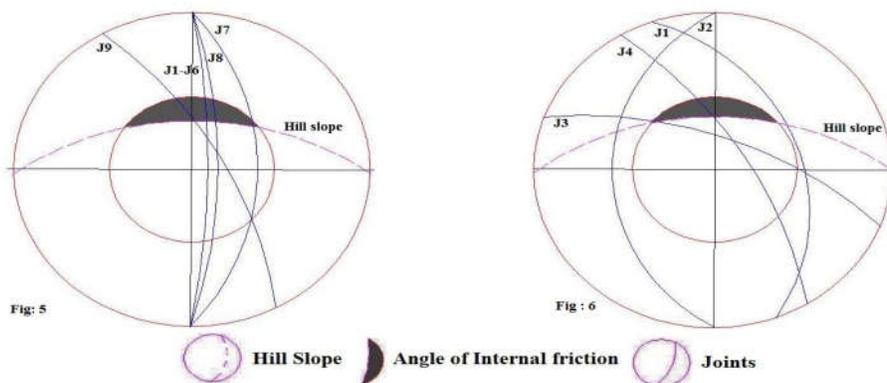
The sector has length of 25 m and the height of the cliff is 8m, and sloping is 30° towards N. Charnockite rock is unaltered. Including 6 parallel joints of C type, nine joints occur in this sector. This sector is found to be stable from geometrical analysis (Fig.5).

The total length of the sector is 25 m and the cliff height is 7 m. The natural slope is 30° towards N. and the road cut slope is 70° N 200. Charnockite with fresh blue quartz feldspar and hypersthene is the rock type. There are four joints present in this sector. (Fig.6).This sector is found to be stable.

Fig.5 and 6: β Diagram for Sectors C and D respectively. Broken arcs are the traces of Slopes, the Inner Circle are the Angle of Internal Friction for the Materials, Crescent shaped shaded areas Represent the Limit for Wedge failure caused by intersection of joint planed.

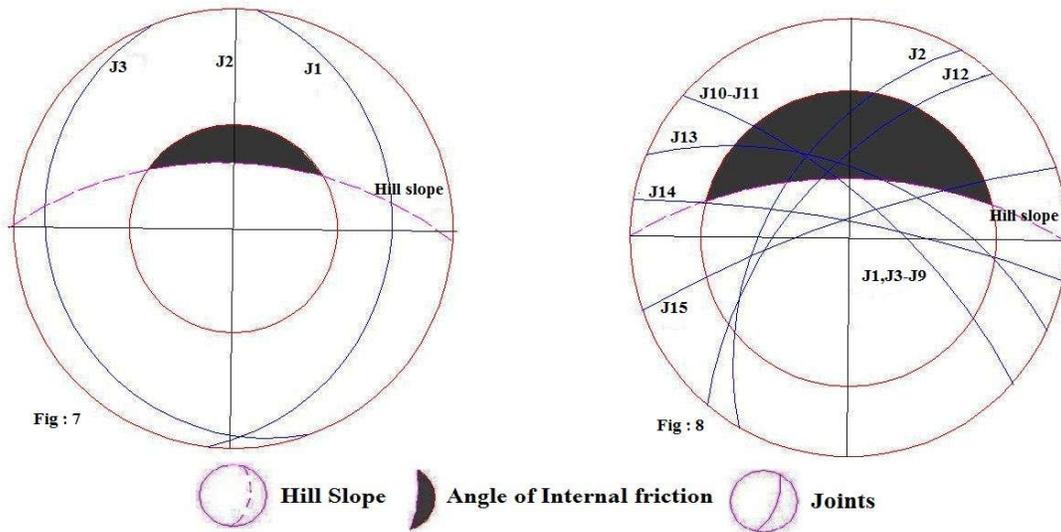
The total length of the sector is 25 m and the cliff height is 8m. Three joints including one vertical joint are observed in the sector. Natural hill slope is 30° towards N, and the cut cliff slope is 85° towards North (Fig. 7). This sector is presently stable.

Length of the sector is 25 m and the height of the cliff is 7m. The hill natural slope is 30° towards N and the cliff slope is 70° towards N. The main rock type charnockite and is highly weathered. Fifteen joints including 7 parallel joints are observed in this sector. (Fig.8).The intersection of J12 and J13 falls within a crescent shaped area, and the intersection plunge 50° towards N350. J12 and J13 are also the potential surface identified as wedge failure. The factor of safety of the sector is estimated as 1.28 at dry condition and is reduced to 0.68 when wet. There are 12 joints are A category and 3 joints are B category. Whereas J3 to J9 are parallel joints.

Fig.7 and 8: β Diagram for Sectors E and F. Broken arcs are the traces of Slopes, the Inner Circle are the Angle of Internal Friction for the Materials, Crescent shaped shaded areas represent the Limit for Wedge failure caused by intersection of joint planed

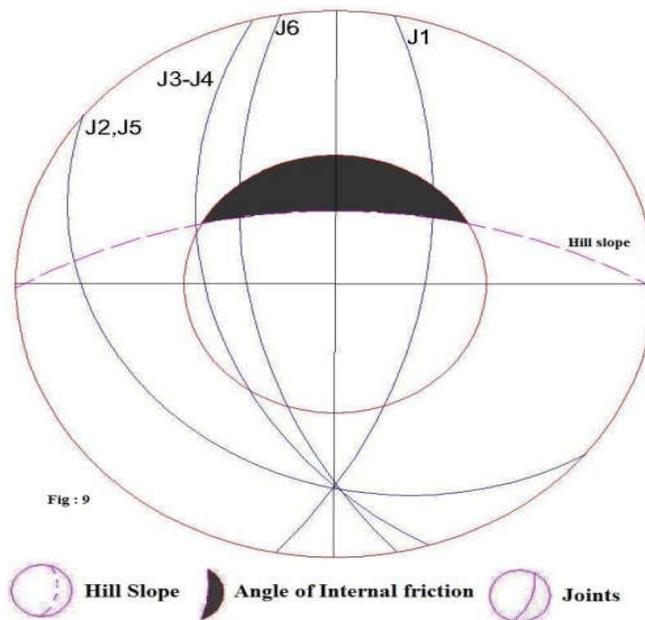
Length of the sector is 25 m. and the height of the cliff is 7 m. the cliff slope is 30° towards N. and the cliff slope is 70° towards N. The charnockite is highly weathered. A pegmatite vein is seen in this sector. Width of the pegmatite vein is around 30 cm. six joints were observed in the area. All the joints are dipping away from the cliff slope (Fig.9). This sector is highly stable.

Fig.9: β Diagram for Sector G. Broken arcs are the traces of Slopes, the Inner Circle are the Angle of Internal Friction for the Materials, Crescent shaped shaded areas represent the Limit for Wedge failure caused by intersection of joint planed.
