# Role of discontinuities in the determination of slope stability at Pattikad along NH-47, Kerala.

**Abstract** - slope failure is one of the major concerns along highways all around the world. Mannuthi- Kuthiran road segment is one such region which is highly vulnerable and suffers from recurrent rock slide and fall mostly in the rainy season. The steep and highly jointed rock cut cliffs along the road makes the zone prone to slope failure due to the infiltration of water during rainy season. Attempts have been made in this study to understand the stability of the cut cliff. The influence of joints on the stability of slopes is determined using Markland test. The study shows that some sections of the cliff face is highly unstable taking into consideration the environmental condition and heavy traffic. Proper case is to be taken to avoid potential hazard in the area.

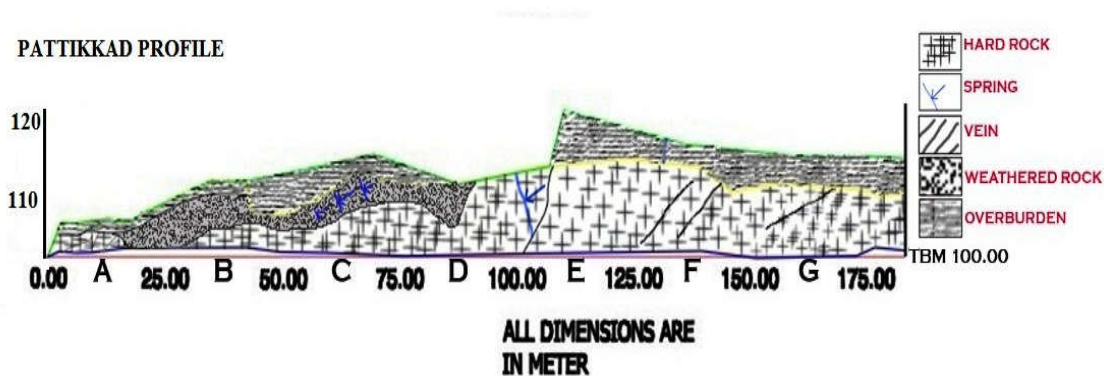
Fig.2: Longitudinal Profile of the Road cut cliff A, B, C, D, E, F and G are sectors

Pattikkad profile is located 15 Km away from Thrissur along the Palakkad road at longitude  $76^{\circ}20' 1.39''$  and latitude  $10^{\circ} 33' 25.41''$ . The road cut in this locality is very steep. The natural slope of the hillock is  $30^{\circ}$  towards north. The height of the cut cliff ranges from 3 to 8m. The total length of the profile is 225m (Fig. 2).

Seasonal water seepage is also observed in this area. The road is at an elevation of 120m above MSL. The maximum height of the hillock is 125m. The entire profile is divided into seven sectors: A, B, C, D, E, F and G. Though hill slopes is characterized by mixed vegetations. Road cut cliff is sparsely vegetated. The slope angle of each section, Lithology, unconfined compressive strength, joint types, friction angle, Bulk density, Dip of joint intersection, Types of probable failure, Factor of Safety at dry and wet condition is found out and presented in Table.1

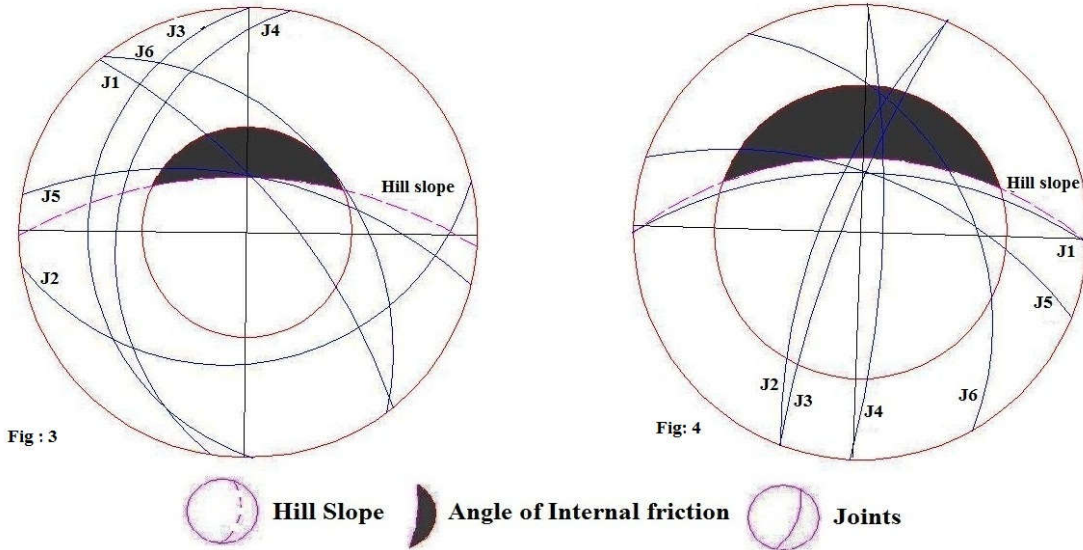
Fig.3 and 4:  $\beta$  Diagram for Sectors A and B respectively. Broken arcs are the traces of Slopes, the Inner Circle are the Angle of Internal Friction for the materials; Crescent shaped shaded areas represent the Limit for Wedge failure caused by intersection of joint planed.

The length of the sector (Fig.3) is 25 m and the height of the cult cliff is ranges from 3.5m-4m. The slope of cut cliff is 60° towards N. There are four major joints (A type) in the sector. Probability for the occurrences of the wedge and plane failure is identified from the  $\beta$  diagram (Fig. 3). Factor safety of the slope is 0.89, when the rocks are wet. Intersection of J1 and J5 falls within the crescent shaped area. The plunge of the intersection is 60 N 30. Chances of plane failure also exist in the sector along the potential slide surface J5. Factor of safety of the cut slope is 1.453 at dry condition and it becomes unstable during wet condition (FOS 0.89)

Length of the sector is 25 m and the height of the cut cliff is 5m. The cliff is slopping 52° towards north. The major rock type is charnockite and is highly weathered. There are 10 joints including 4 parallel joints in this sector. During rain storms water seeps through the discontinuities and in the presence of water along these joints, factor of safety may be further reduced to 0.45. Occurrences of the wedge failure are probable in this sector. Slumping of debris is seen in the sector B, which consists of boulders weathered rock fragments and lateritic soil (Fig.4). Factor of safety is less than one even when the rock is dry. The intersection of J2 and J6 falls within the crescent shaped area. The plunge of the intersection is 10°N 27 and is the potential slide surface along which a wedge failure can occur. The rock is sitting safely because of the presence of joints with irregular surface.

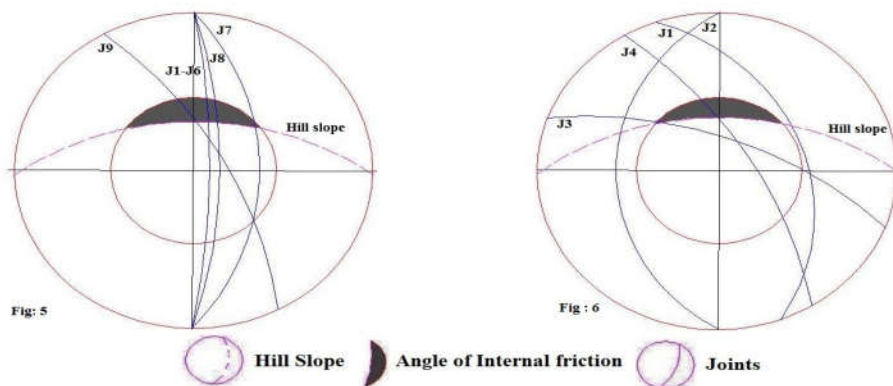
Fig.5 and 6:  $\beta$  Diagram for Sectors C and D respectively. Broken arcs are the traces of Slopes, the Inner Circle are the Angle of Internal Friction for the Materials, Crescent shaped shaded areas Represent the Limit for Wedge failure caused by intersection of joint planed.

The sector has length of 25 m and the height of the cliff is 8m, and sloping is  $30^\circ$  towards N. Charnockite rock is unaltered. Including 6 parallel joints of C type, nine joints occur in this sector. This sector is found to be stable from geometrical analysis (Fig.5).

The total length of the sector is 25 m and the cliff height is 7 m. The natural slope is  $30^\circ$  towards N. and the road cut slope is  $70^\circ$  N 200. Charnockite with fresh blue quartz feldspar and hypersthene is the rock type. There are four joints present in this sector. (Fig.6).This sector is found to be stable.

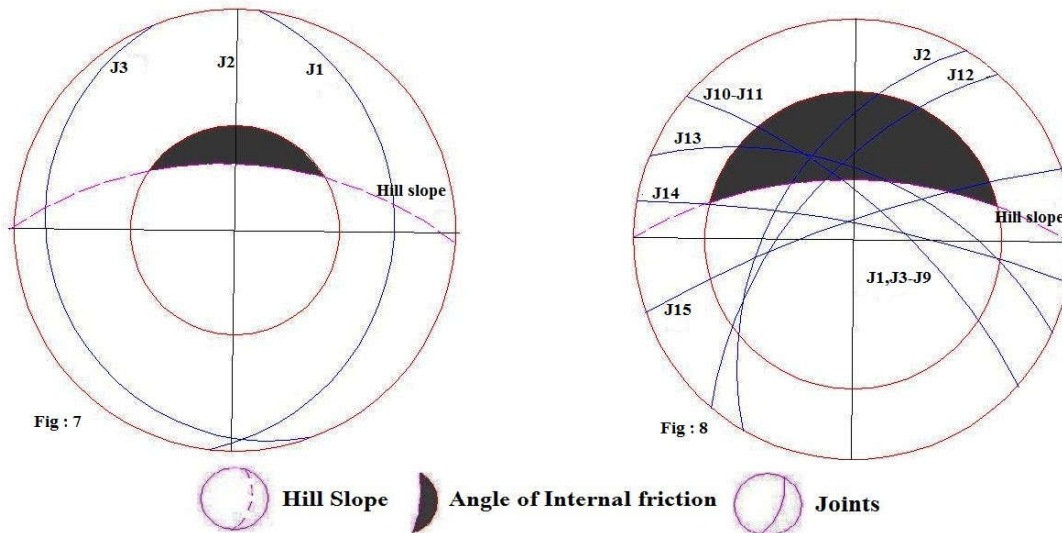
Fig.7 and 8:  $\beta$  Diagram for Sectors E and F. Broken arcs are the traces of Slopes, the Inner Circle are the Angle of Internal Friction for the Materials, Crescent shaped shaded areas represent the Limit for Wedge failure caused by intersection of joint planed

The total length of the sector is 25 m and the cliff height is 8m. Three joints including one vertical joint are observed in the sector. Natural hill slope is 30° towards N, and the cut cliff slope is 85° towards North (Fig. 7). This sector is presently stable.

Length of the sector is 25 m and the height of the cliff is 7m. The hill natural slope is 30° towards N and the cliff slope is 70 ° towards N. The main rock type charnockite and is highly weathered. Fifteen joints including 7 parallel joints are observed in this sector. (Fig.8).The intersection of J12 and J13 falls within a crescent shaped area, and the intersection plunge 50° towards N350. J12 and J13 are also the potential surface identified as wedge failure. The factor of safety of the sector is estimated as 1.28 at dry condition and is reduced to 0.68 when wet. There are 12 joints are A category and 3 joints are B category. Whereas J3 to J9 are parallel joints.

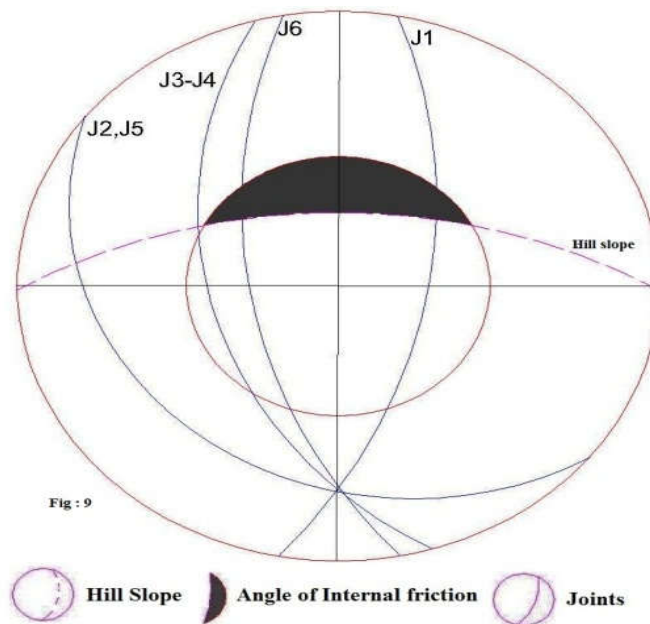
Fig.9:  $\beta$  Diagram for Sector G. Broken arcs are the traces of Slopes, the Inner Circle are the Angle of Internal Friction for the Materials, Crescent shaped shaded areas represent the Limit for Wedge failure caused by intersection of joint planed.

Length of the sector is 25 m. and the height of the cliff is 7 m. the cliff slope is  $30^\circ$  towards N. and the cliff slope is  $70^\circ$  towards N. The charnockite is highly weathered. A pegmatite vein is seen in this sector. Width of the pegmatite vein is around 30 cm. six joints were observed in the area. All the joints are dipping away from the cliff slope (Fig.9). This sector is highly stable.
